**UPPER TANK
IN-SERVICE INSPECTION**

**SAVARY SHORES IMPROVEMENT DISTRICT
SAVARY ISLAND, BC**

Date: June 9, 2025

TANK #1
IN-SERVICE INSPECTION

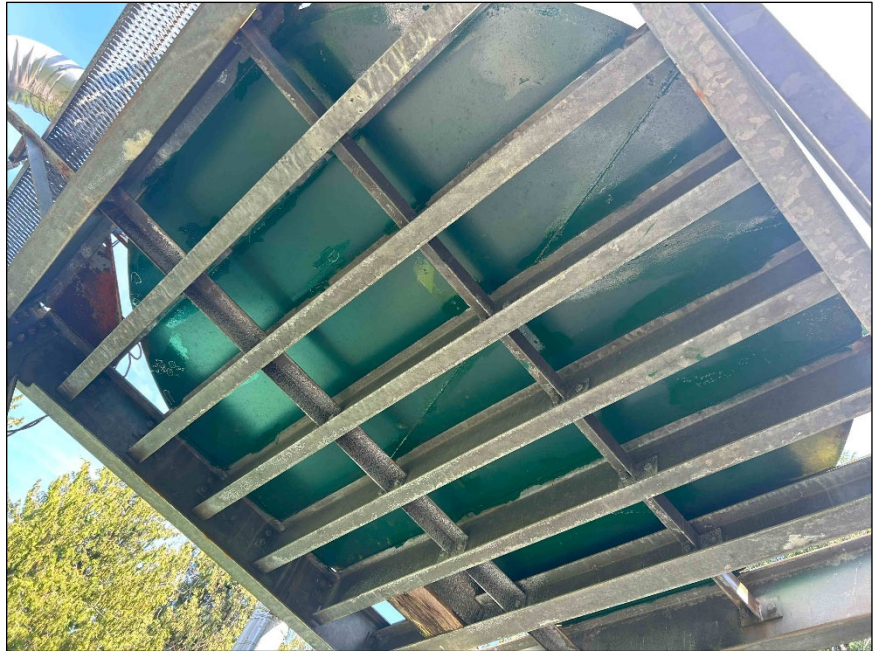
Photo 4:

- VT of the external bottom supports did not reveal any signs of structure deformation. The galvanized I-beams had areas of corrosion and degradation. The material loss was estimated to be less than 0.001". The support I-beam and structure should be inspected during the next in-service inspection of the tank. Refer to Photo 4.

Bottom plate overview.

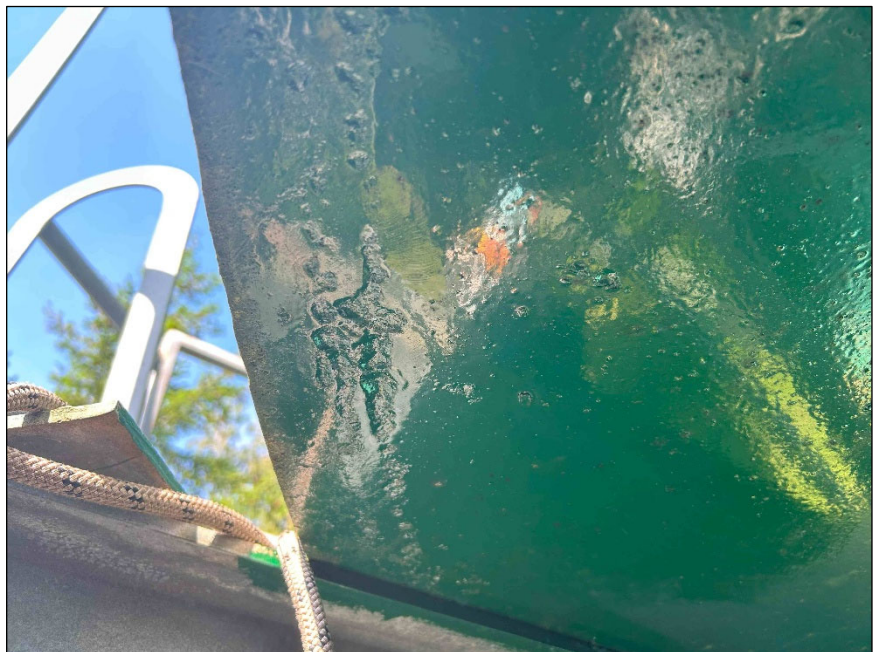
Photo 5:

- VT of the external shell-to-bottom weld did not reveal any signs of degradation (i.e., leakage or corrosion).
- VT of the tank bottom below the structure was completed. Areas of bottom side material loss were observed. The bottom side corrosion features were located around the perimeter of the tank and along the floor-to-floor weld. The bottom side corrosion had been re-coated during the last inspection. The repair coatings were in good condition except for some areas where the substrate was not fully prepared. Corrosion products could be seen under the paint. These areas should be monitored during the next inspection. Refer to Photos 5 to 7 for typical locations.

Corrosion damaged areas were painted from previous inspection.

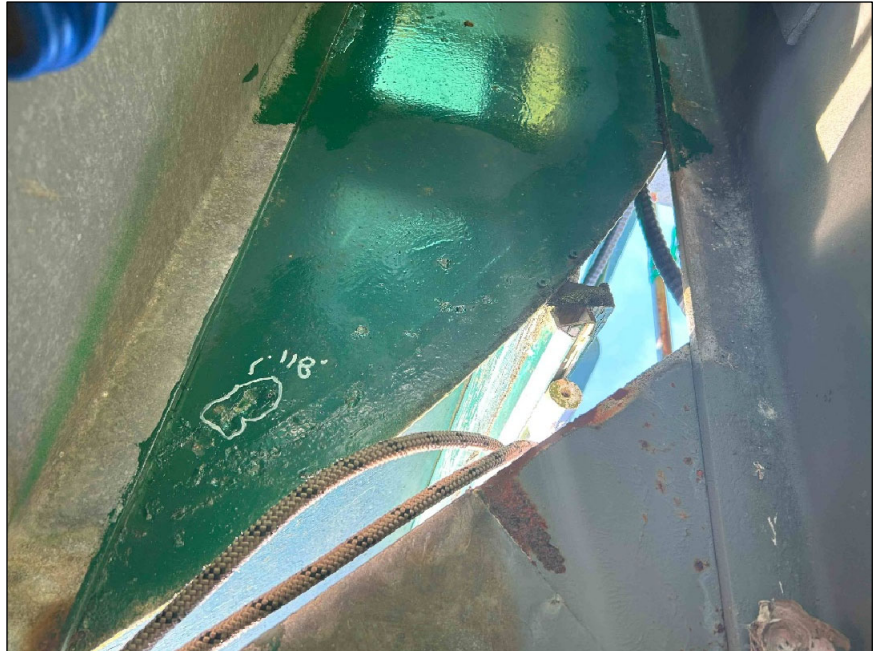
Photo 6:

- Spot UT readings were taken at the bottom side corrosion locations. The lowest measurement recorded was 0.118" on the southeast side. The estimated circumference distance is 32'. The location was re-coated during the last inspection.

Location with the lowest remaining wall thickness was marked for monitoring.

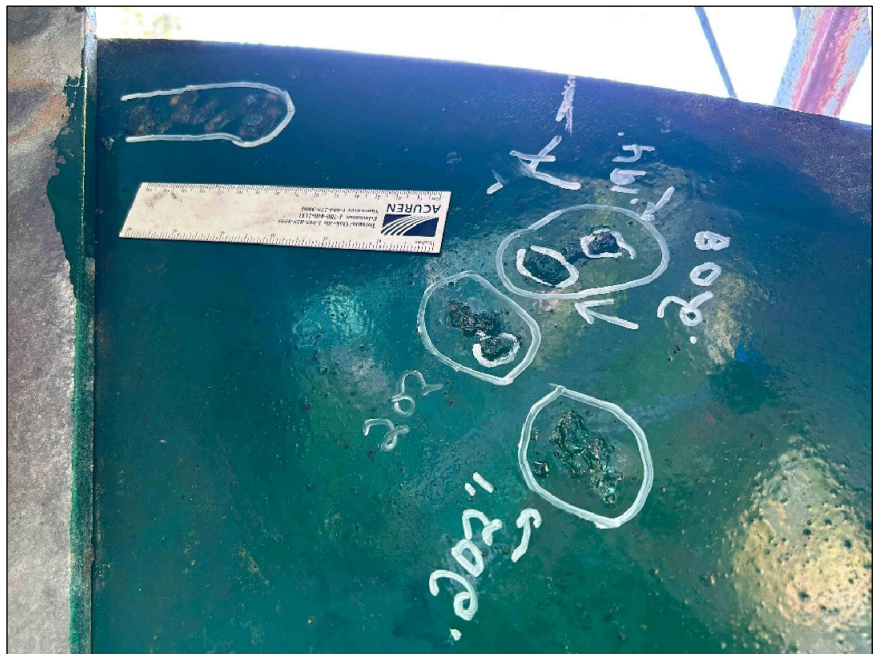
Photo 7:

Various clusters of corrosion under coating were marked.

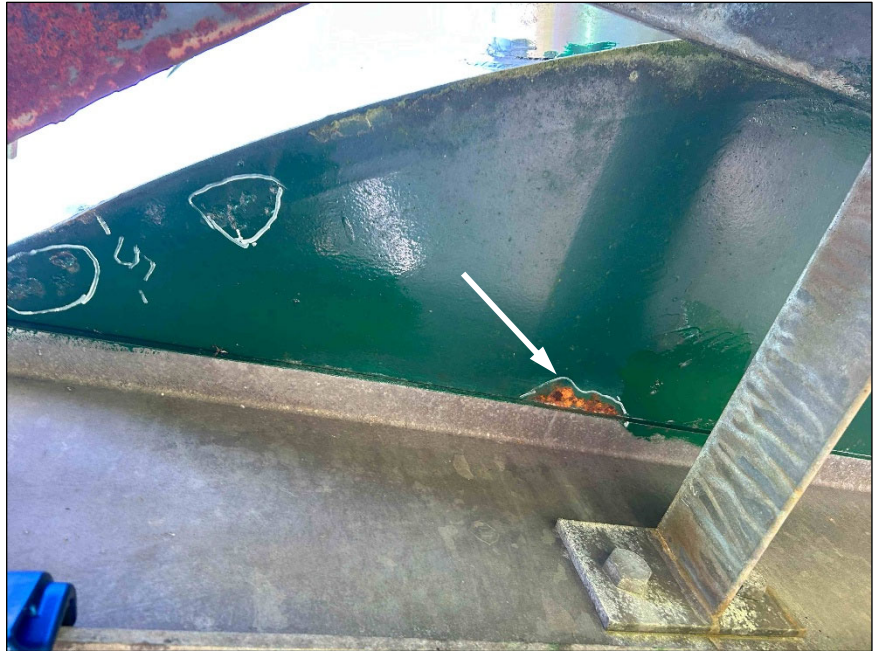
Photo 8:

- The tank bottom between the I-beams and the floor were not accessible for inspection. One (1) location had corrosion products underneath the I-beams at the 5' location and one (1) other location that appeared to have corrosion staining. There should be consideration for inspecting the locations underneath the I-beams by utilizing advanced NDE methods or entering the tank and inspecting the bottom floor from inside the tank during the next scheduled inspection. Refer to Photo 8 and 9.

Exposed and unprotected section of the floor at the I-beam-to-floor crevice.

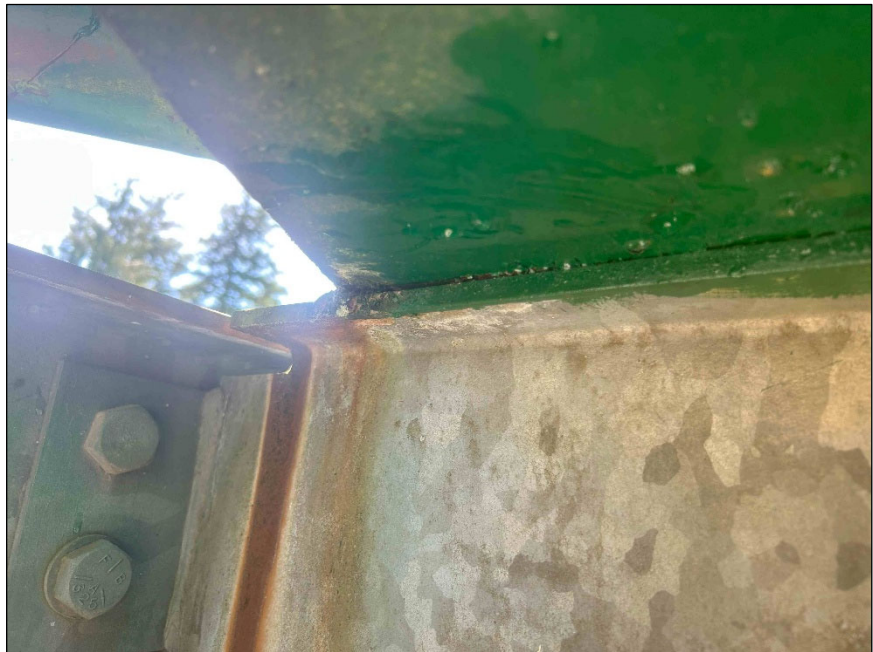
Photo 9:

Staining on steel structure originating from the recoated crevice.

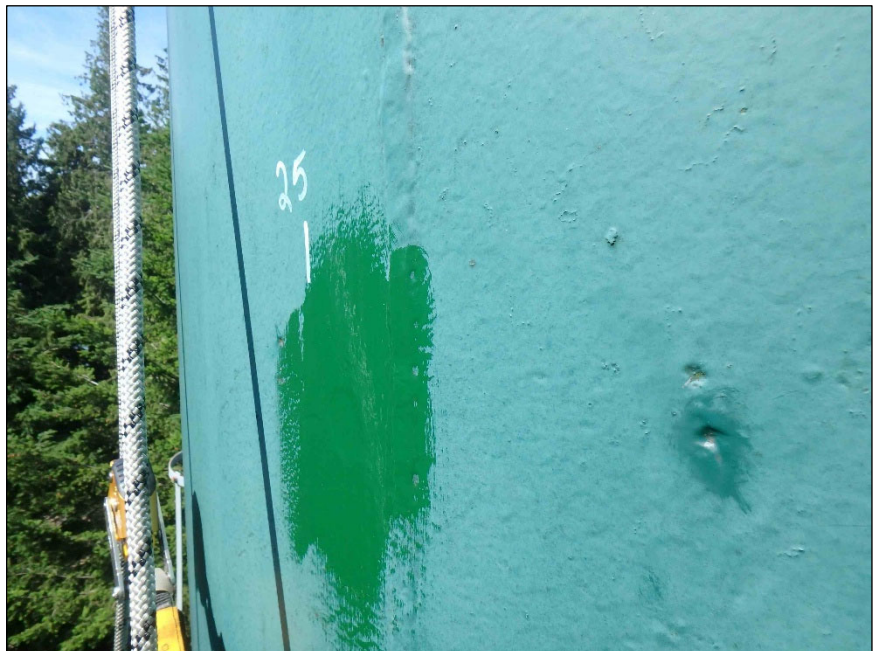
Photo 11:

- An isolated pit with a depth of less than 0.050" was observed adjacent to the 25' circumferential location. Refer to Photo 11.
- The tank was measured in four (4) locations with a plumb level. The tank was tilted to the northwest. The tank is leaning towards the drain.

A localized pit was observed. The pit was coated.

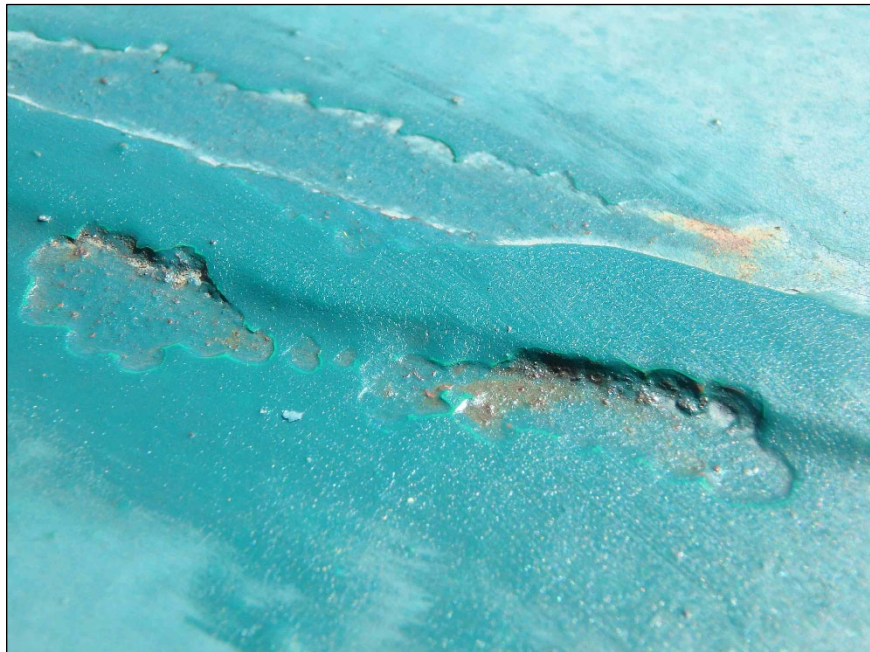
Photo 13:

Roof coating failure locations along the weld toe.

- d. The estimated 5% of the failed coating on the roof should be considered for appropriate abrasive preparation to ensure the substrate achieves a proper anchor profile, and a coating applied in accordance with the API 650 and environmental considerations.

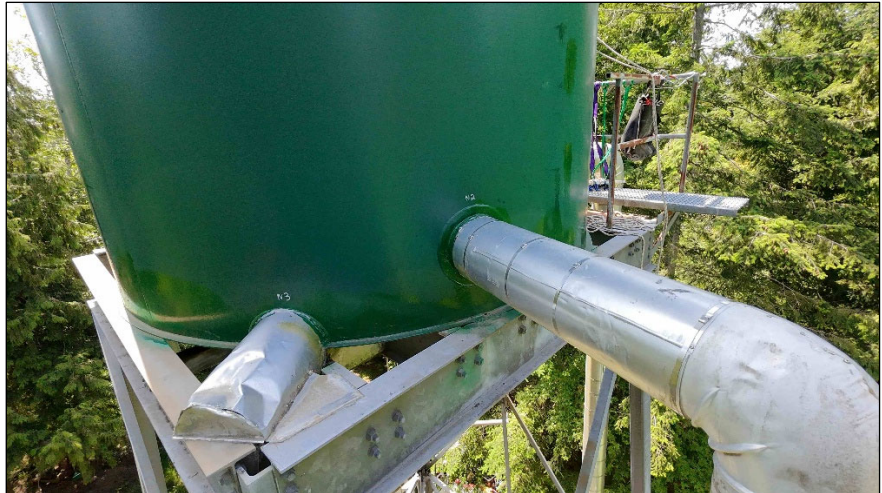
Photo 14:

- VT of the accessible nozzles did not reveal any signs of external degradation (i.e., leakage or corrosion). Three (3) of the four (4) nozzles were covered in insulation up to the shell of the tank. The insulation should be reviewed to be removed back from the shell to allow inspection of the shell, repad and nozzle connection to the tank. Refer Photo 14.

Insulation of the piping is installed up to the shell.

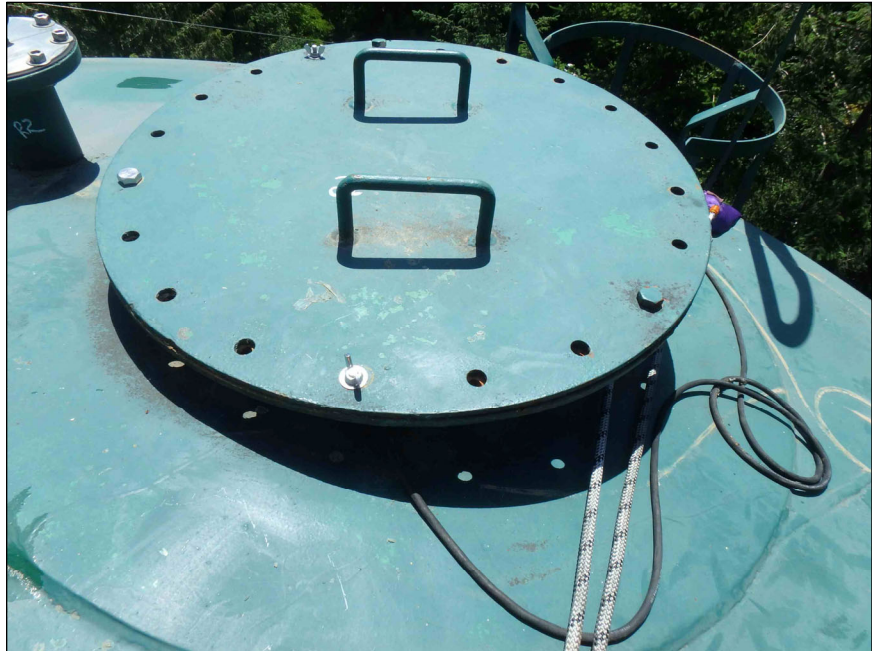
Photo 16:

- Manway on the roof only utilized four (4) of the 20 bolt holes to fasten the cover. Consideration should be made to replace the bolts to prevent deterioration between the gasket sealing surface. Refer to Photo 16.

Roof manway overview.

- f. The manway on the roof was missing 21 bolts and fasteners for the manway. The bolts should be replaced to seal the manway in accordance with the manufacturer's design and prevent deterioration between the manway gasket sealing surface.

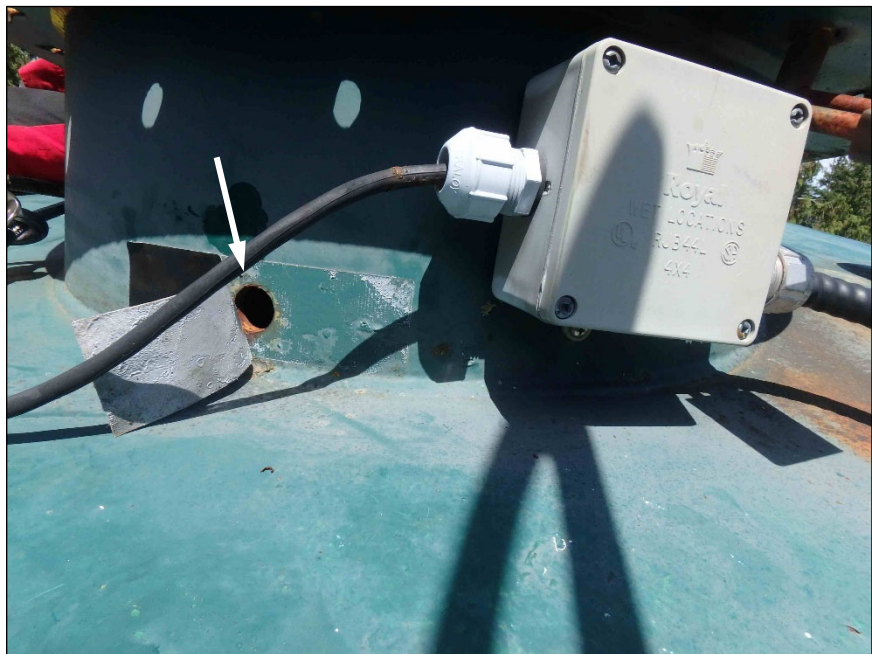
Photo 17:

Arrow indicates the drilled hole covered with duct tape on the manway neck.

- g. Two (2) mechanically drilled holes on the manway nozzle neck should have the tape removed and the holes repaired.
- h. The wooden gauge mount on the southeast side of the tank has separated from the tank shell. A review of the manual float gauge should be considered. The gauge should be repaired or removed if not in use.

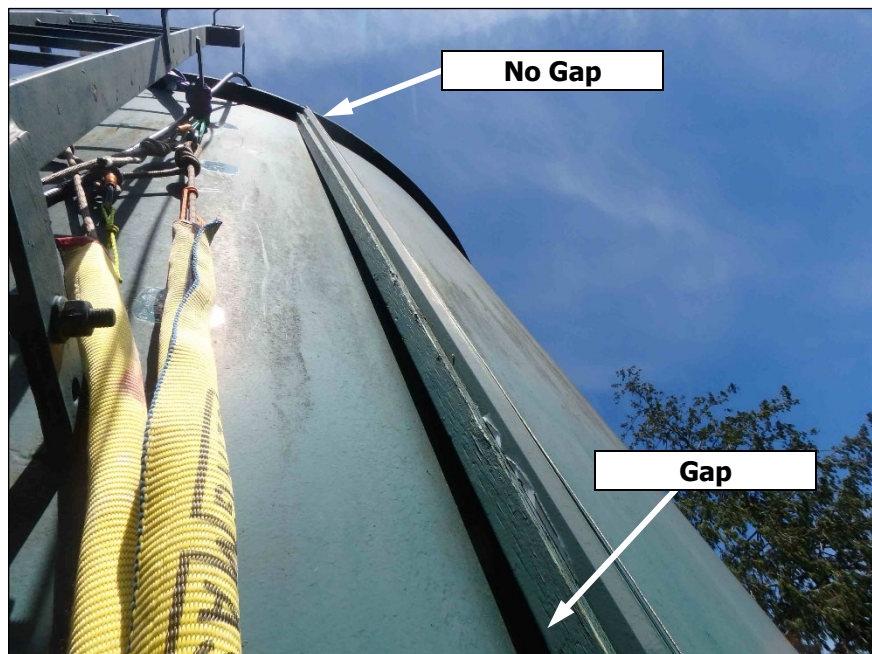
Photo 19:

- The ladder was inspected visually and did not show any signs of degradation that would limit its serviceability. Refer to Photo 18.
- A wooden gauge mount on the Southeast side of the tank has separated from the tank shell. A review of the manual float gauge should be considered. The gauge should be repaired or removed if not in use. Refer to Photo 19.

Gauge mount.

Arrow indicates the misalignment of the gauge mount.

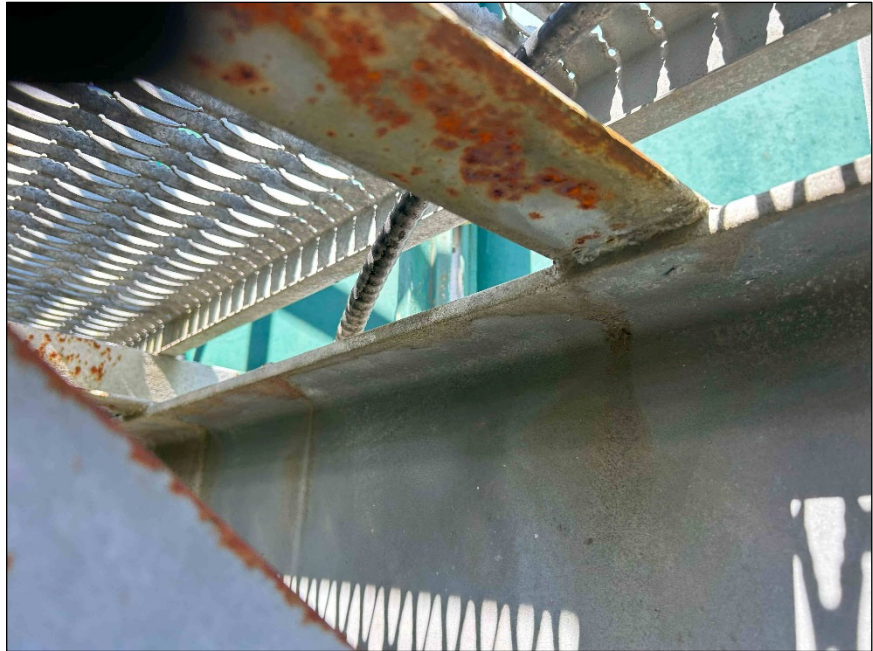
Photo 20:

- Isolated rust buildup and corrosion was observed on the platform frame, particularly in areas of standing water and material exposed to the marine atmosphere. Refer to Photo 16.

Areas of rust buildup on the steel structure.

- d. A slight deflection of the ladder cage was observed. It should be monitored for continued service.
- e. Atmospheric corrosion was noted on 5-10% of the beams on the steel structure. The deterioration should be monitored during the next in-service inspection.

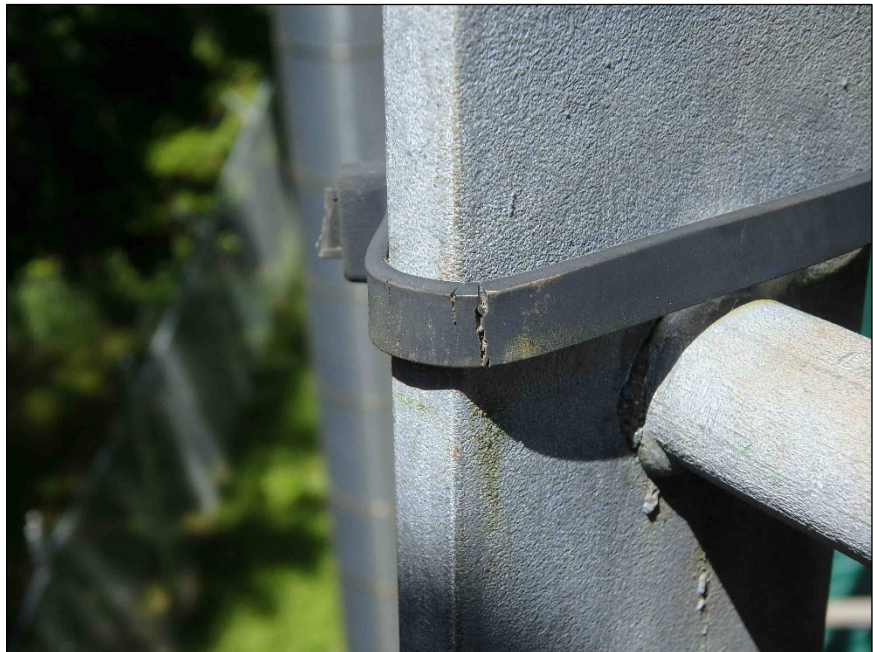
Photo 21:

- Plastic zip-ties used to fasten the electronic gauging cable had brittle cracks due to sun and UV exposure and should be replaced. Refer to Photo 17.

deteriorated zip ties used to fasten cable for tank instrumentation.

- i. Plastic zip-ties used to fasten the electronic gauging cable had brittle cracks due to sun and UV exposure. They should be considered for replacement with a more permanent solution.
- j. Insulation on Nozzle N3 was damaged on the top of the insulation. This may lead to water ingress and cause Corrosion Under Insulation (CUI). Insulation repair should be considered.

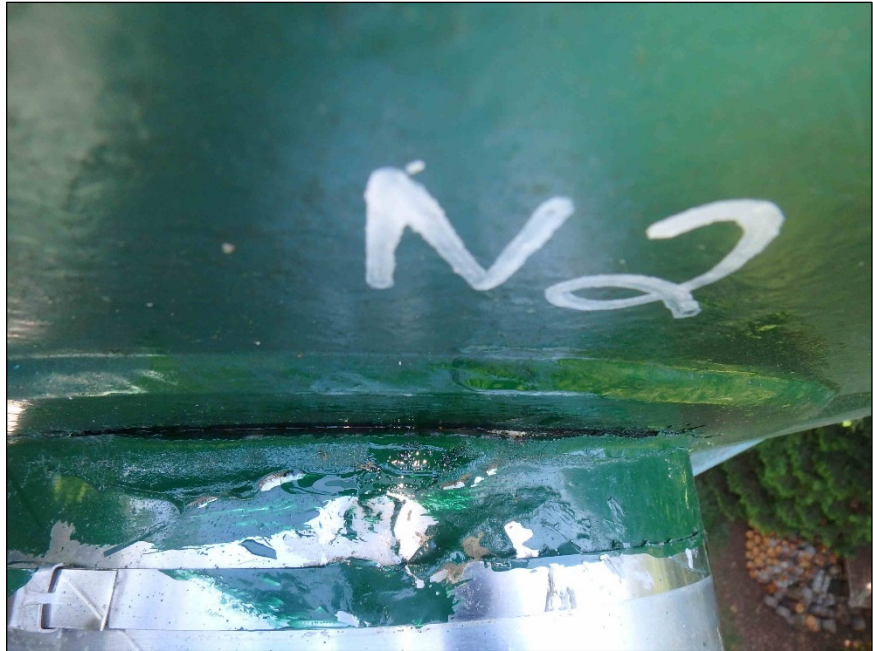
Photo 22:

- Insulation-to-repad caulking seals have been damaged and should be restored to prevent water ingress. Consideration should be for removing the insulation from the shell to allow access to the nozzles for inspection. Refer to Photo 22.

Insulation caulking seal has separated and should be renewed or removed back for future inspections.

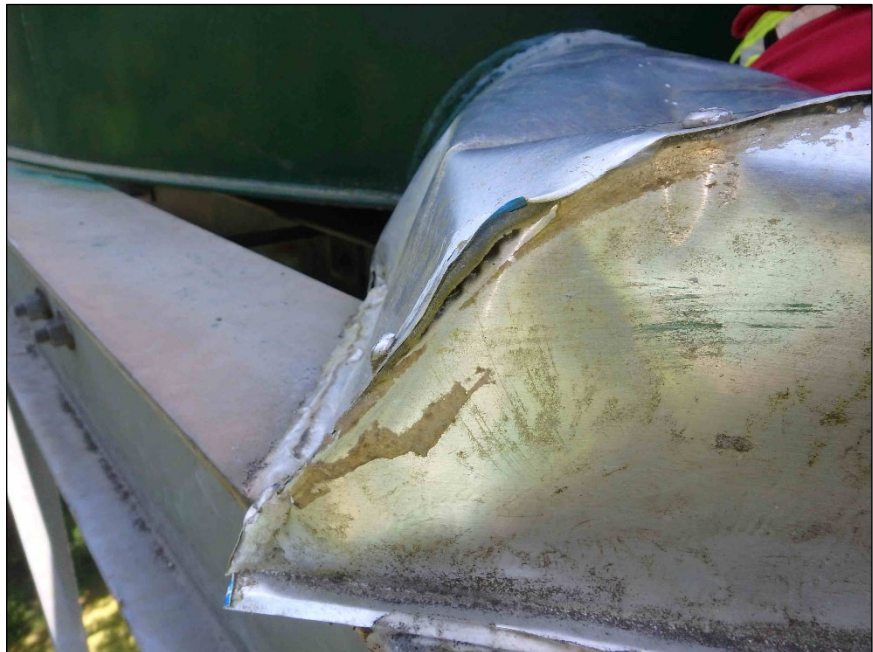
Photo 23:

- Insulation at Nozzle N3 had been damaged top side, protection from the atmosphere is uncertain without repair or replacement. Refer to Photo 23.
- The ladder was inspected visually and did not show any signs of degradation that would limit its serviceability.

Damaged insulation cladding at Nozzle N3 overview.

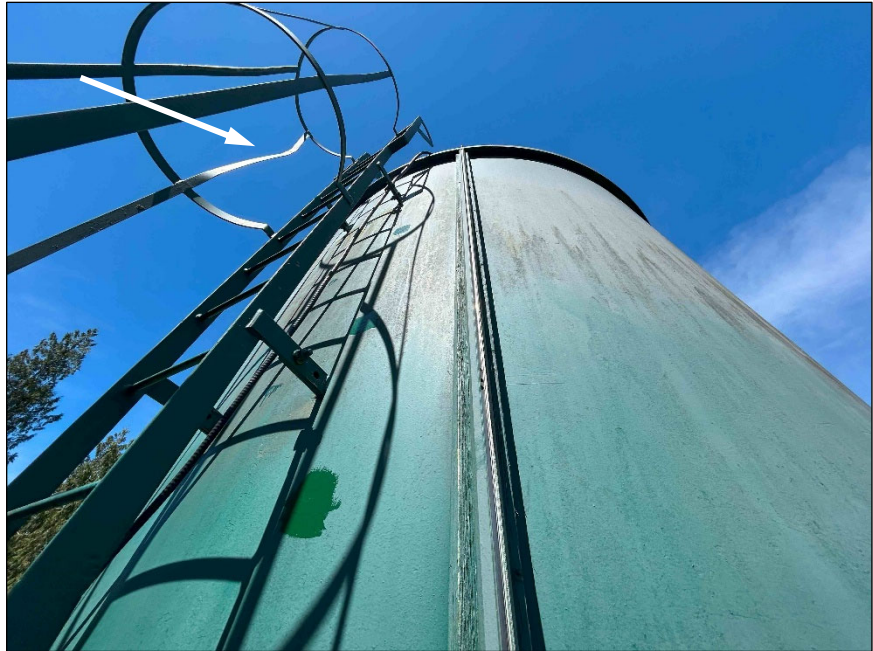
Photo 24:

- A slight deflection of the ladder cage was observed on the upper portion of the roof ladder. Refer to Photo 24.

Deflected ladder cage.

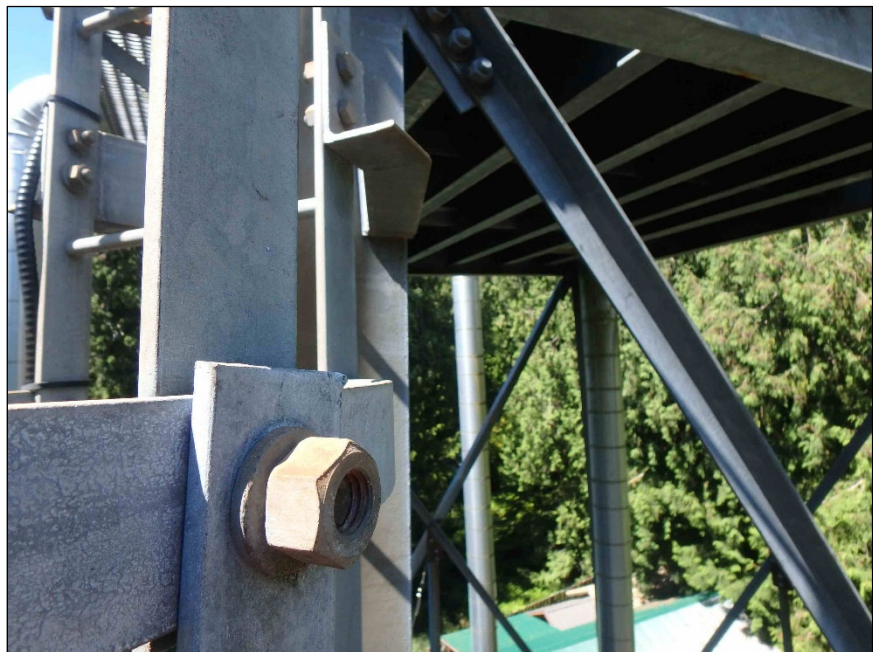
Photo 25:

- The nuts on the structure ladder cage at the top of the ladder are not fully engaged. They should be monitored to ensure they do not back off and cause the ladder cage to come loose or become a drop hazard. Refer to Photo 25.

Overview of the structure ladder with the nut not fully engaged.

- a. The nuts on the ladder cage at the top of the ladder were not fully engaged. The nuts should be monitored to ensure they do not back off and cause the ladder cage to come loose or become a drop hazard.

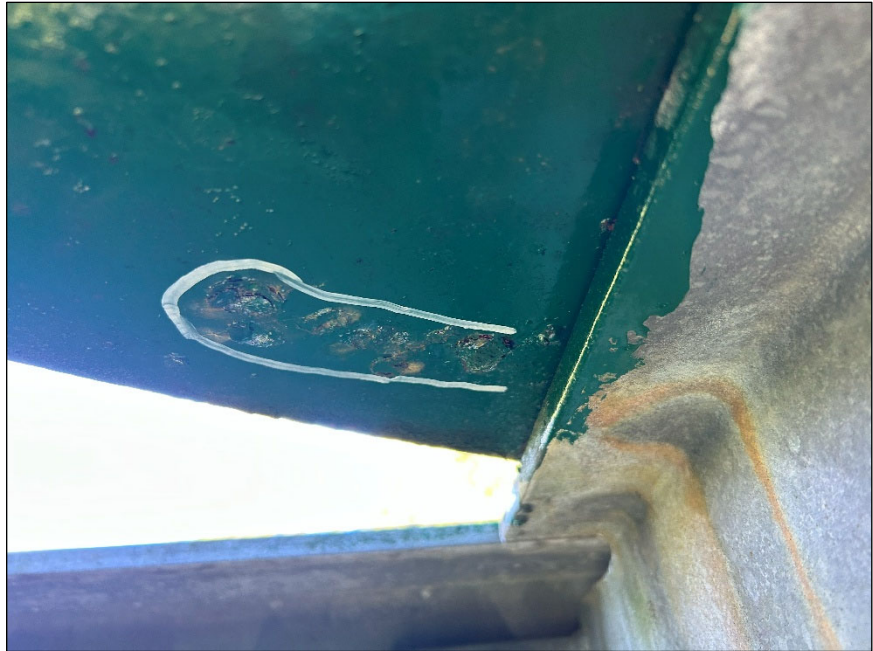
Photo 26:

- The tank bottom coating repairs at the pitting locations were still intact. An estimated 20% of the coating repairs were not prepared appropriately, and corrosion product was seen beneath the applied repair. This may cause water ingress and corrosion may still develop at these locations. The locations should be monitored for continued deterioration and appropriate coating should be considered to be applied. Refer to Photo 26.

Corrosion clustered observed below the tank on the bottom plate.

- c. The locations of material loss on the tank bottom appear to be from a damage mechanism that is no longer available. It is assumed that the visible material loss will not degrade further other than in areas where the coating was not appropriately applied. It is recommended to have an engineering assessment for repairs during the next out of service inspection or in-service inspection.

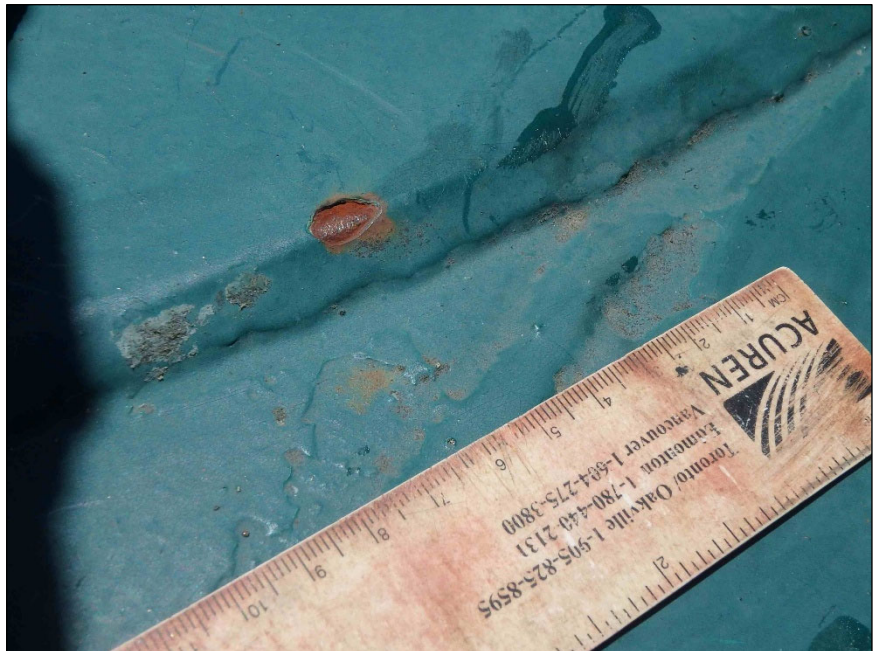
Photo 27:

- Less than 5% of the coating was deteriorated or damaged. These locations should be considered for repair during the next inspection. Refer to Photo 27.

Typical isolated damaged coating.

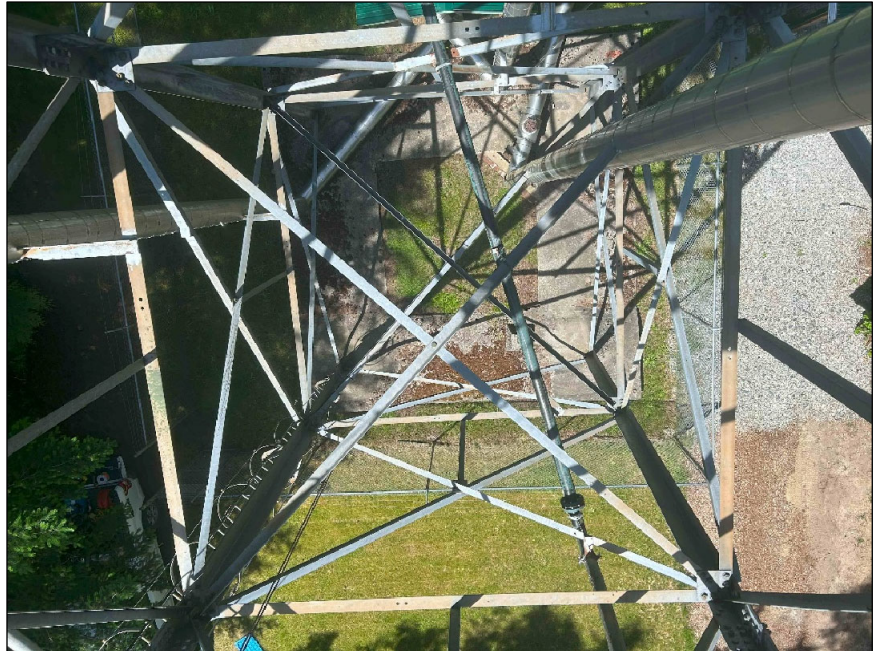
Photo 28:

- The tank is elevated above a concrete foundation and does not show any signs of degradation. Refer to Photo 28.
- The north I-beam had deflected up on the bottom flange. Refer to Photo 29.
- Atmospheric corrosion was noted on 5-10% of the beams of the steel structure. Refer to Photos 30 and 21.
- The wooden block used to support Nozzle N3 shroud has deteriorated, its condition should be reviewed for continued service, and it should be considered for replacement with appropriate pipe support. Refer to Photo 28.

Overview of the steel structure looking down from the tank bottom.

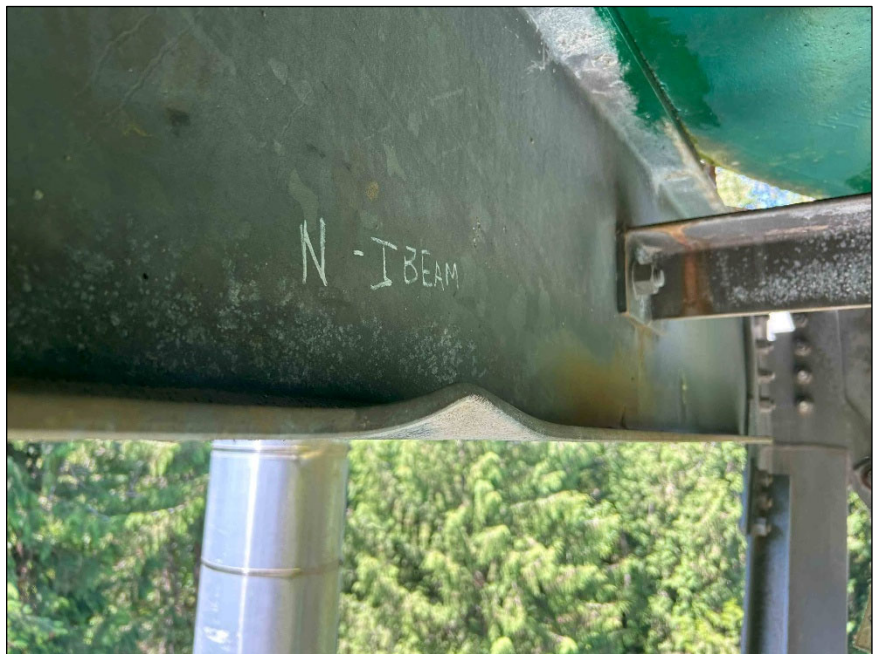
Photo 29:

Isolated deflection on North I-beam.

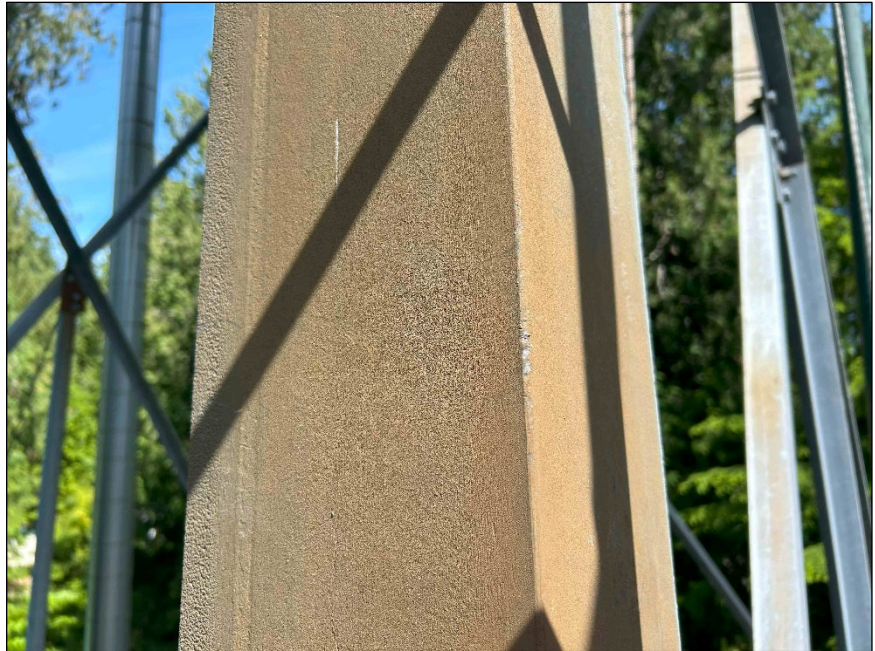
Photo 30:

Discoloration of the galvanic protection failure.

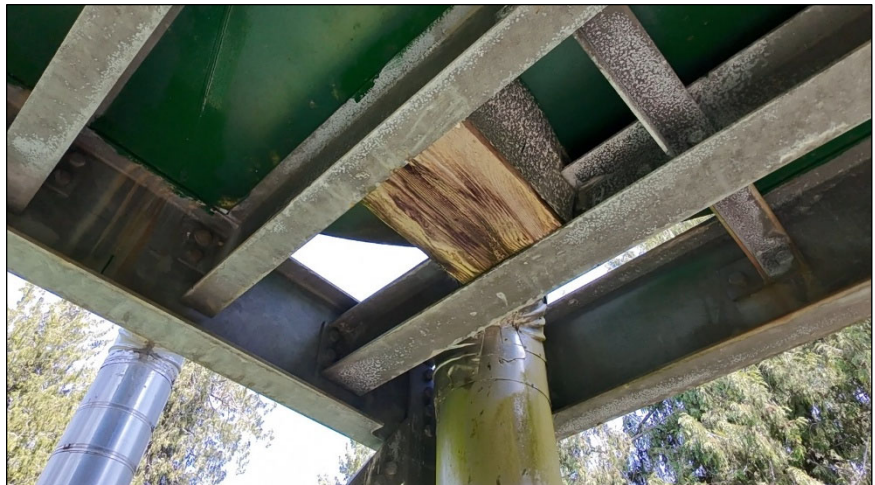
Photo 31:

Wooden support for the shroud at Nozzle N3.

- f. The wooden block used to support Nozzle 3 has deteriorated. Its condition should be reviewed for continued service, and it should be considered for replacement with appropriate pipe support.
